Ashland Lakefront Property

***Comprehensive Environmental  
Investigation Report***

Ashland, Wisconsin

SEH No. WIDNR9401.00

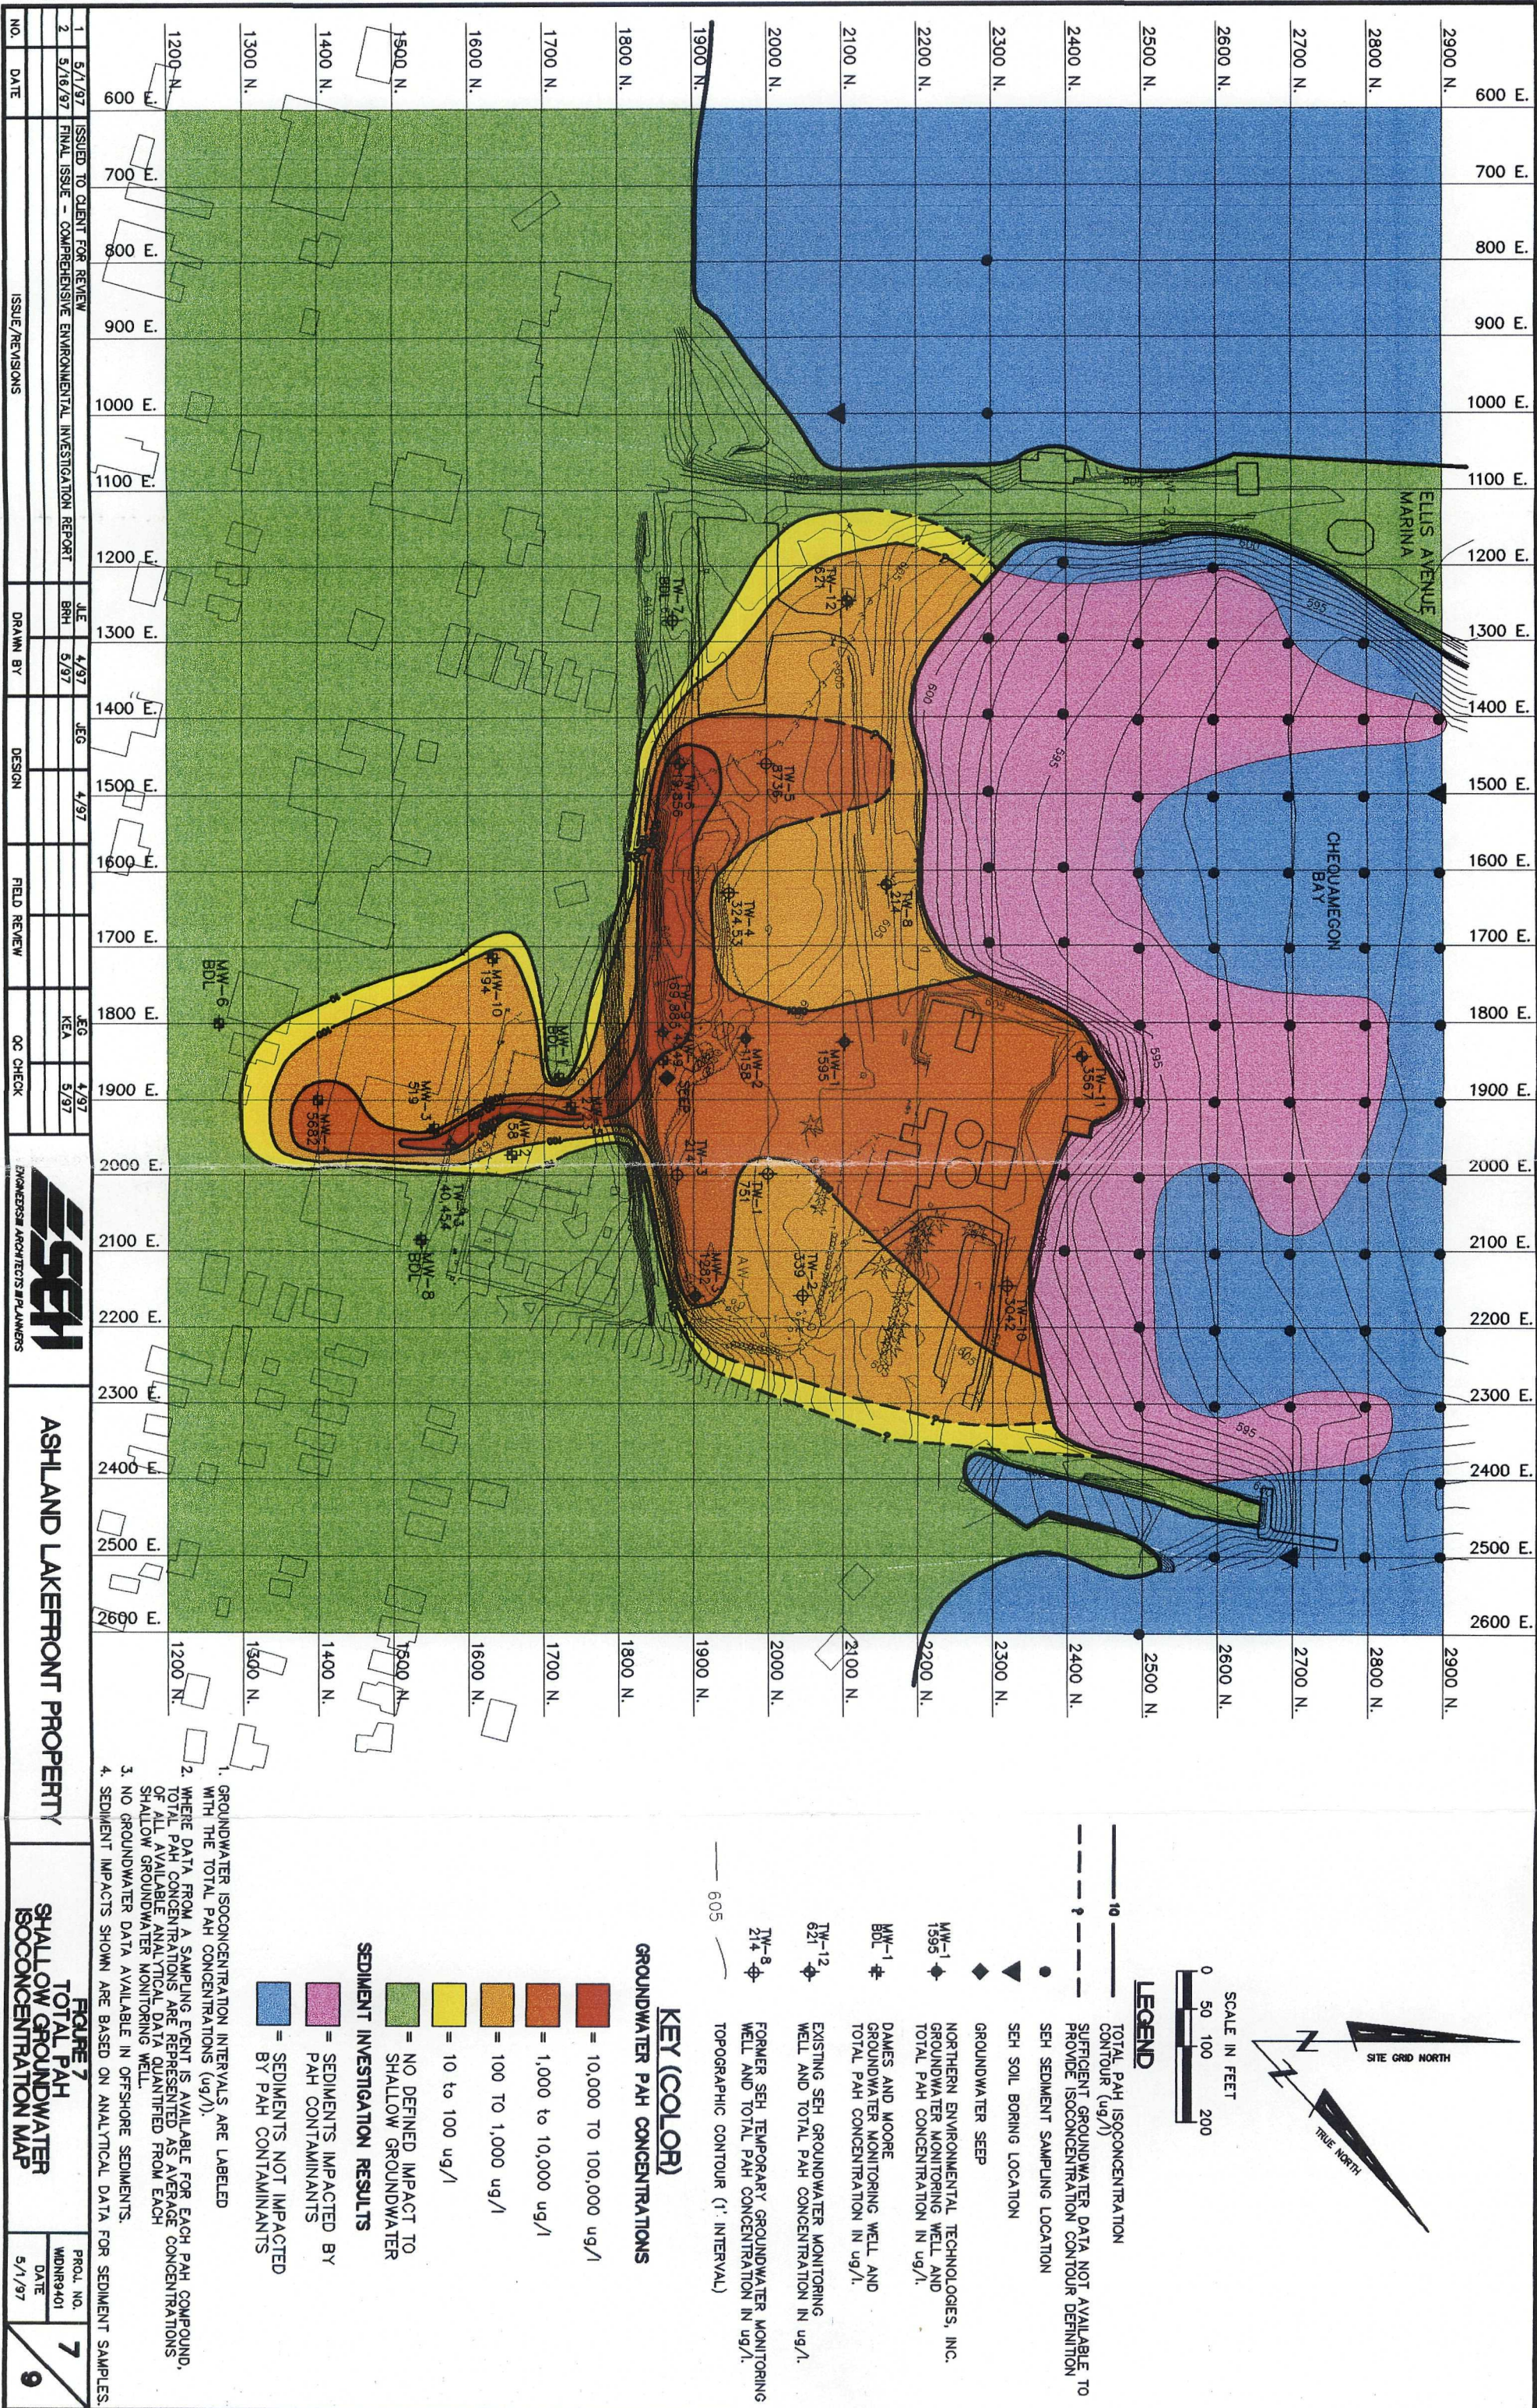
**FIGURE 6**

Figure 6, “Total BETX Shallow Groundwater Isoconcentration Map” depicts groundwater total BETX concentrations in plan view. Figure 7, “Total PAH Shallow Groundwater Isoconcentration Map” depicts total PAH concentrations in plan view. Figure 8, “Groundwater Isoconcentration Contours, BETX” depicts total BETX concentrations in cross section. Figure 9, “Groundwater Isoconcentration Contours, Total PAHs” depicts total PAH concentrations in cross section.

Widespread VOC contamination has been identified in the shallow soils at the Ashland Lakefront Property and in the former ravine area. The VOCs consist predominantly of the BETX compounds as well as naphthalene. However, since naphthalene is also included as a parameter in the PAH range, naphthalene contamination will be discussed only in the PAH subsections to avoid redundancy. In addition, several areas of apparent grossly contaminated soils (e.g., “coal tar saturated soils” in Dames and Moore borings B-19 and B-20) which were not analyzed for total concentrations of VOCs (TCLP analysis was performed) were identified during investigation of the former ravine area. No TCLP exceedances for VOCs were identified in the soils analyzed from the former ravine area. No TCLP analysis has been performed to-date on soils from the Ashland Lakefront Property. The extent of VOC-impacted soils approximates the area of shallow groundwater BETX contamination depicted on Figure 6.
